## **The Definitive Guide to Battery/System Garage Refurbishment**

***The first section of this website / booklet shows examples of over 20 Battery or System Garage types and their before and after states.***

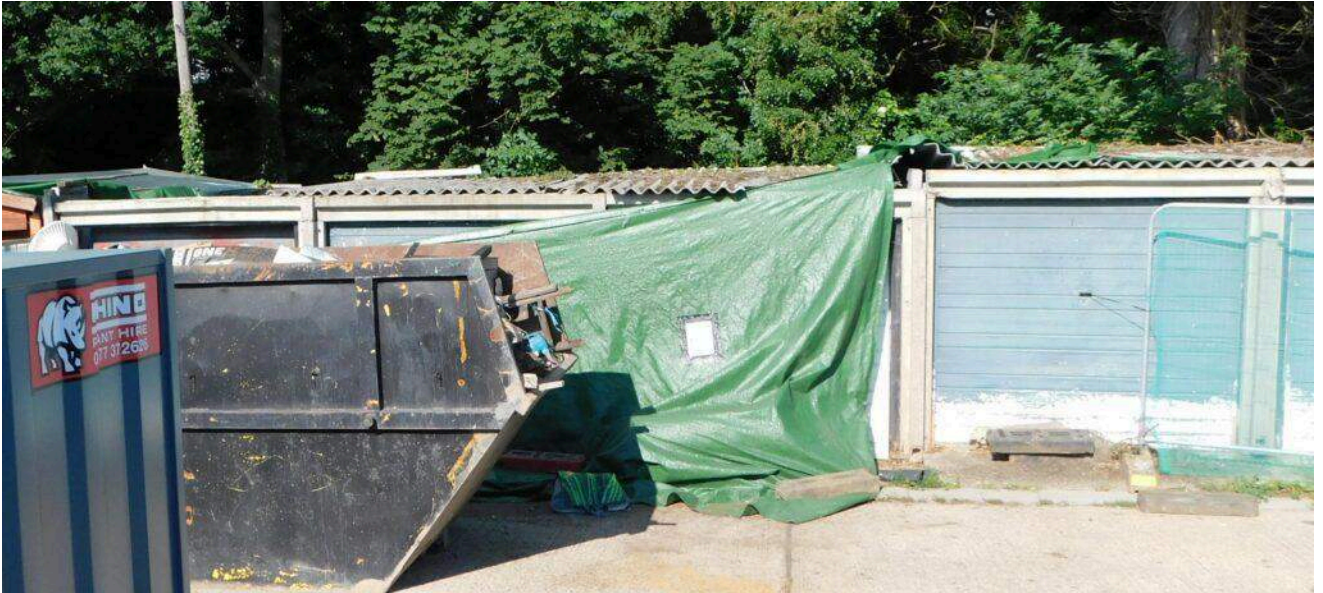
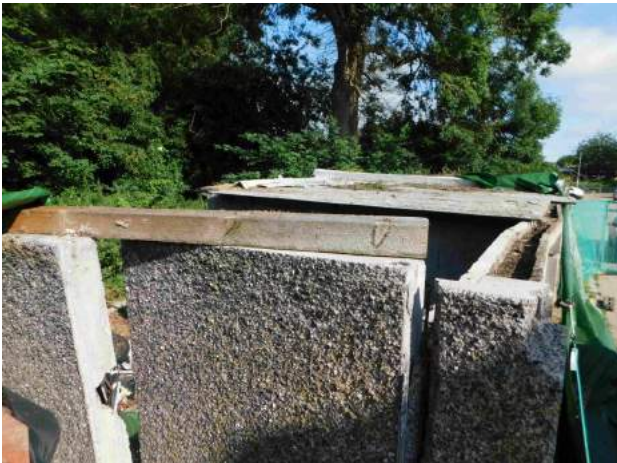
This block of System B Garages was partly demolished by a large tree falling in the middle of the first four garages from the left hand end. While we have several moulds for the lintels and posts, of this type, we have but small numbers of moulds for the three types of panels used in this design. Without a quantity of the these moulds it would have taken weeks/months to make enough concrete panels to complete the job. Therefore we used standard Marley-Designed panels for the sides, rear and interwalls of the reconstruction.

The above pictures show the problem. However the marriage of the two systems worked well with the final result maintain the original look and matching the other units in the block.

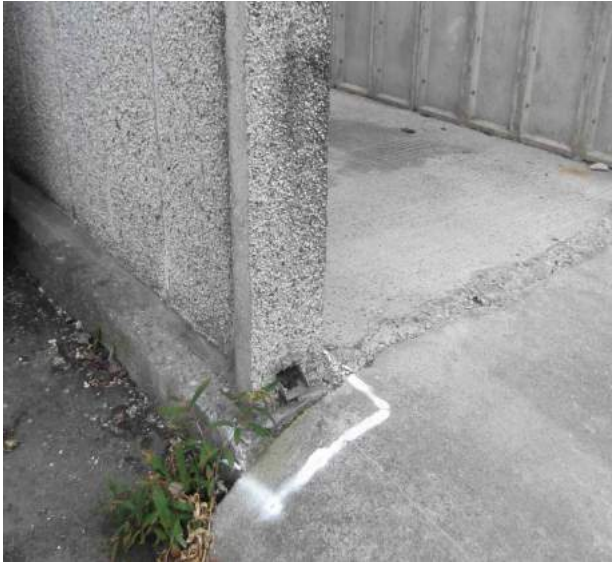
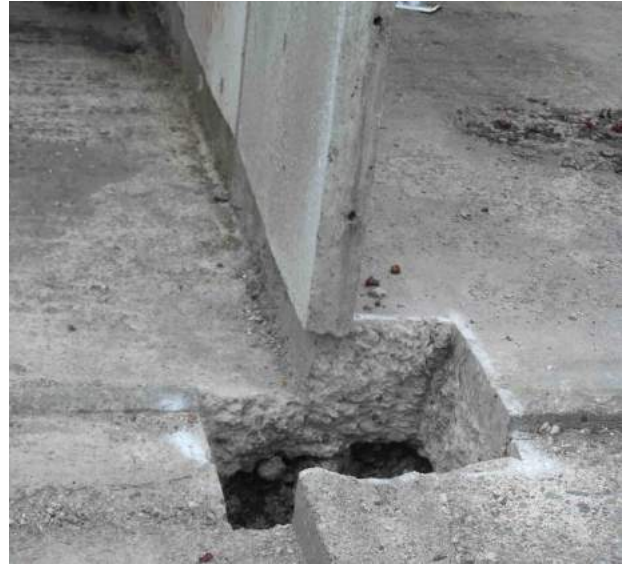
This approach uses conventional brick piers and construction lintels. Firstly the existing base has to be punctured as the column of bricks is far too heavy to be set on the relatively thin concrete pad.

Then the brick pier can be erected in the new deeper foundation. This is a two-stage job that costs money and takes time. Our aluminium posts sit on the existing pad. No concrete has to be cut or excavated. Then the brick pier is constructed, using about £100 of materials and a day and a half's labour (including the ground work).

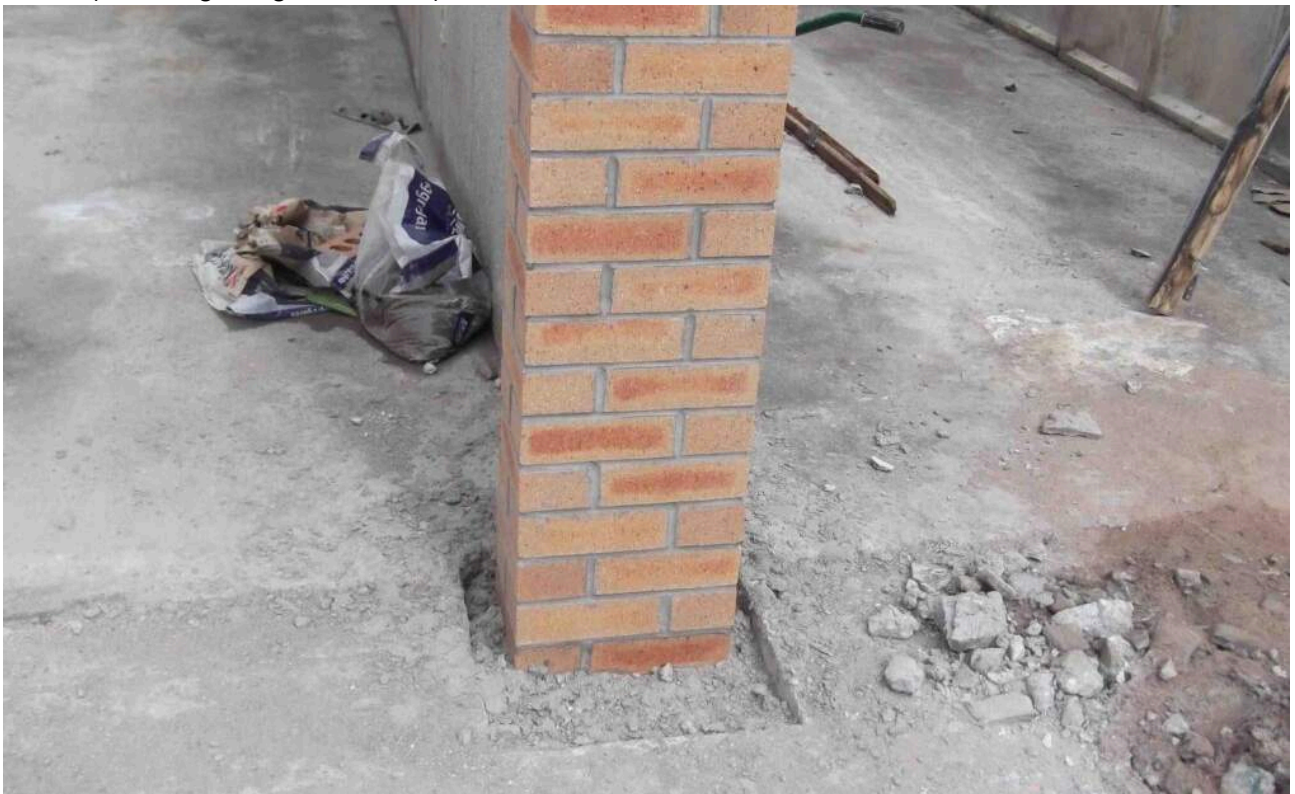
Note that the pier is about 14" wide, and the cassette door will reduce the wing mirror by at least a further 2". That's about 8" less width than with our System LX approach. Furthermore our aluminium posts provide 2.8 times the volume of regular downpipes so they are less likely to block up, they cannot be stolen and never need replacing. Then in this approach to refurbishment a commercial lintel finishes the front off at a factory cost of about £320 as against £87 per aluminium beam in our system. This saves thousands of pounds overall.

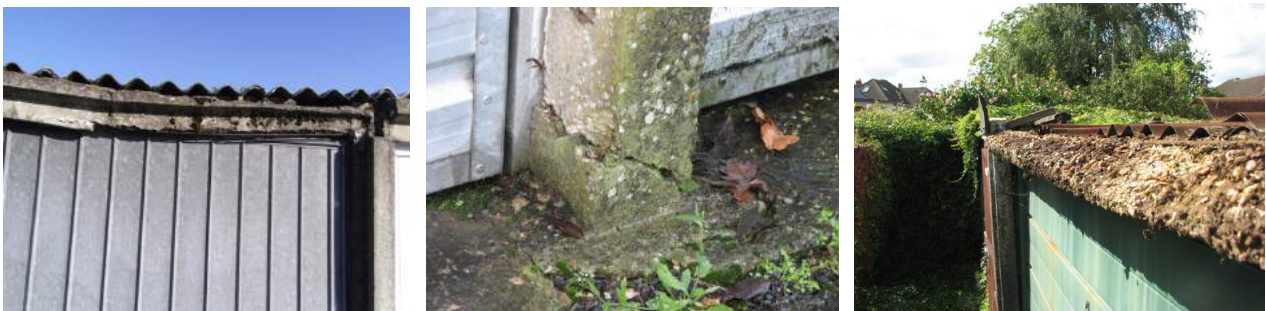
Here are some examples of concrete lintels and posts that are disintegrating:

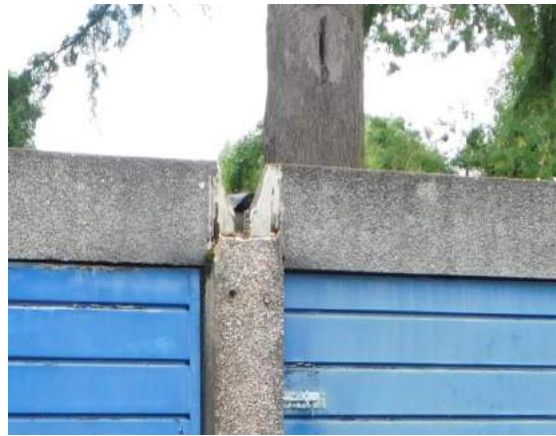
With some Marley models there is a problem with the upstand at the top of the post/downpipe. This extension “blade” at the top of the post breaks off and falls. It weighs about 20 lbs. This could injure anyone standing below it.

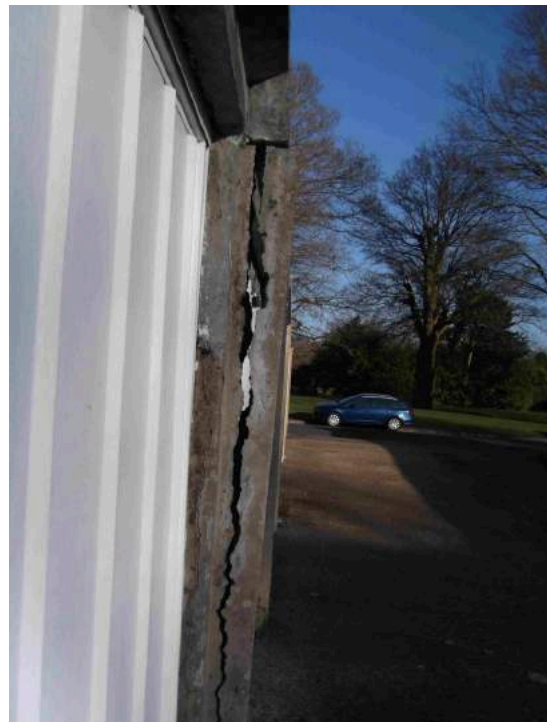
An additional problem here is the post width used by Marley (and others using the same concept) to accommodate their rainwater downpipe. This measures 235mm in width and frames the door. This concrete post not only reduces the Wing Mirror Clearance (WMC) but splits or spalls as shown. This is a result of water freezing in the blocked downpipes.

With a roller shutter door the post/downpipe is the same thickness as the garage dividing wall only the roller shutter door guides protrude into the WMC thus increasing the WMC to 2294mm. Therefore the extra WMC obtained over the original Marley door is  $2294-2179=115\text{mm}$  (nearly 5 inches) and over a Hormann door  $2294-2024=270\text{mm}$  (over 10 inches).

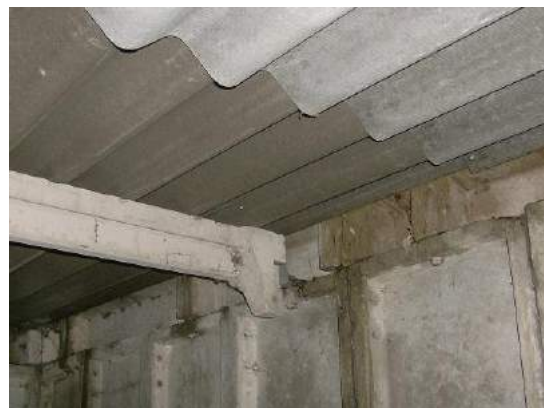
Inside the garage there are more hazards, in particular cracking purlins that support the roof. They start as hairline cracks, often resembling cobweb lines. Rub them, if they disappear they are cobwebs. If they don't then they need to be replaced, and soon.

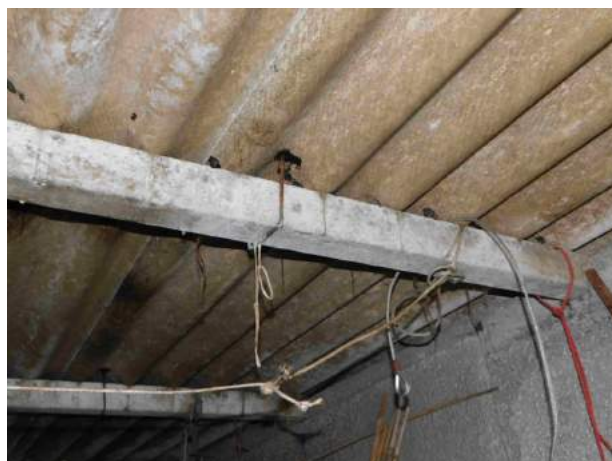
Both asbestos and fibre cement are porous and the build up of moss and other vegetation can take hold. by holding water on the roof longer then the roof material starts to break down and water seeps in. The dark part of the under roof photo shows where this is happening:

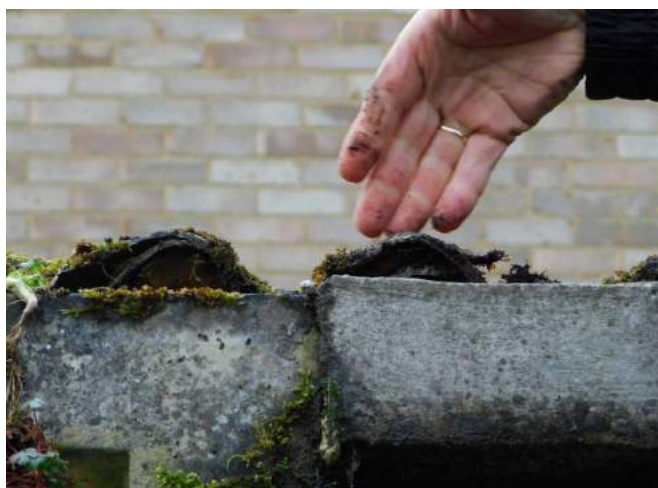
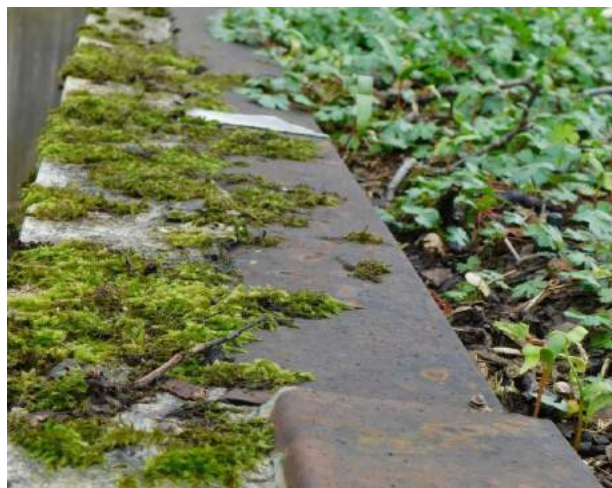
Gutters are important too and the original Marley's had accessible gutters although they proved to be a bit too narrow and needed cleaning out quite often.

With System B the problem is much the same

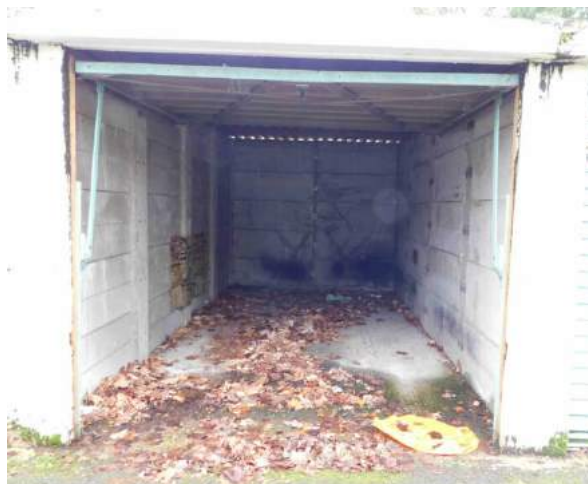
On at least one in four sites we find that since the garages were built 50-70 years ago, resurfacing of the common access area has been carried out, one or more times causing the garage floor level to become lower than the access area. Naturally water flows into the garage.

When we refurbish garages our work is in regard to the replacing of the old components, not in building up the floor level. Another trade is involved which we can organise but it may be cheaper to obtain quotes locally.

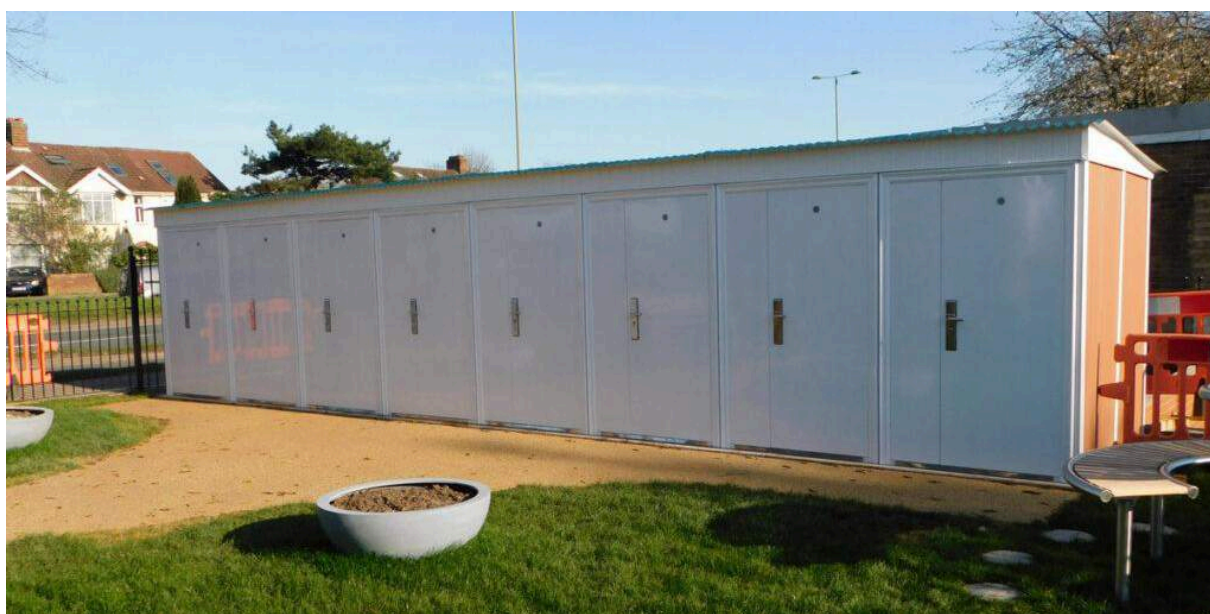
System Garages are often used for general storage and not for vehicle garaging. To provide more options for community storage Leofric have developed a new range. MiniStores as shown below. Call 01386 430 121 for further details or check on this site under Our New Models – MiniStores. Those shown below were built for Oxford City Council.

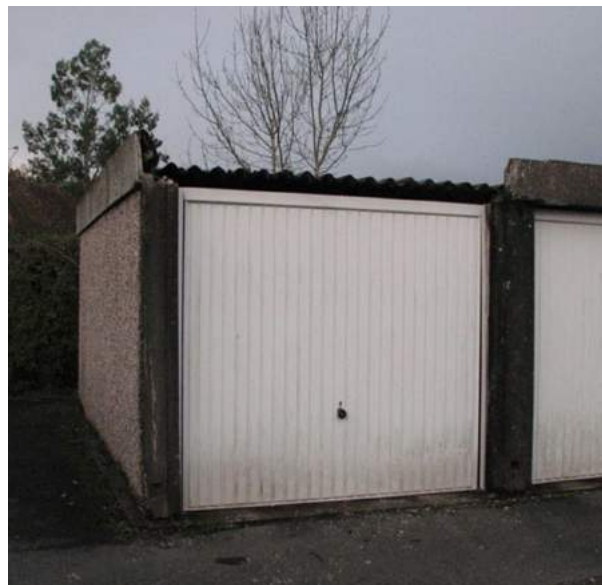
With the two main brands the type of failure is different. The Marley fascia/lintel/gutter has an intricate wire frame and seldom collapses along its length, instead chunks fall off either above or below the centre line, sometimes both.

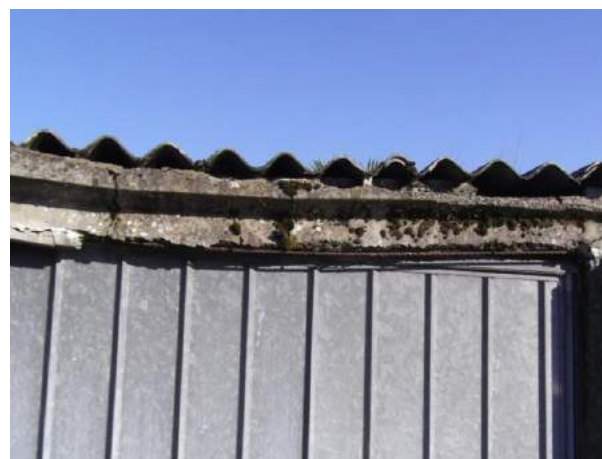
**With System B** the poorer reinforcement design of the fascia/lintel/gutter causes this component to collapse along its length. This is seriously hazardous; in the picture shown it has sunk onto the door which cannot be opened, however when the door is forced open the entire concrete section will fall to the ground.

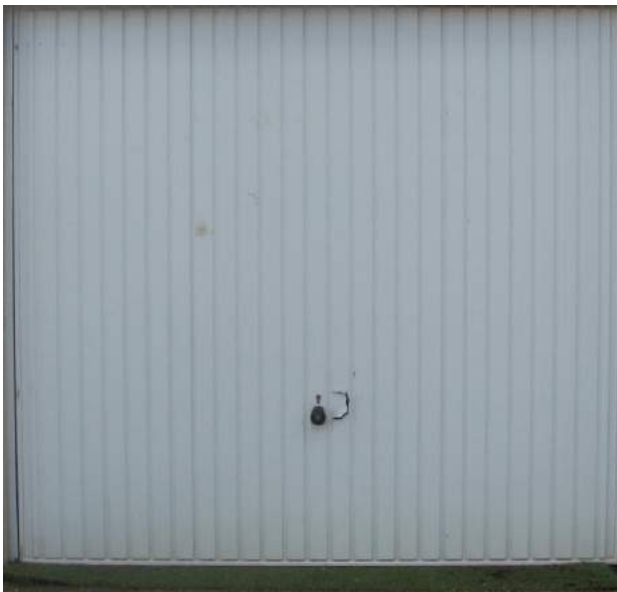
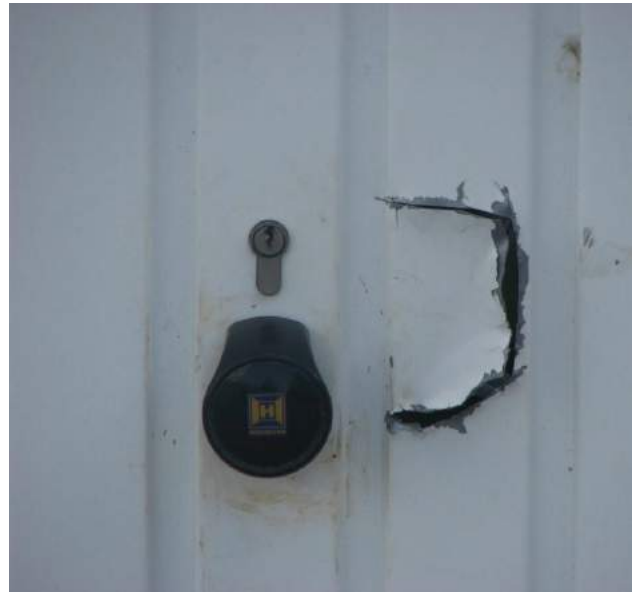
As manufactured, up and over doors rely on rods actuated by a handle to enter sockets in the frame. This sounds secure enough but in reality it offers a low level of security. We have the video of a break-in that took less than 80 seconds to can open the skin of the door, move the operating rods and gain entry to the building. A bar at the base of the door would have stopped this, but such a bar can be cut off with an angle grinder.

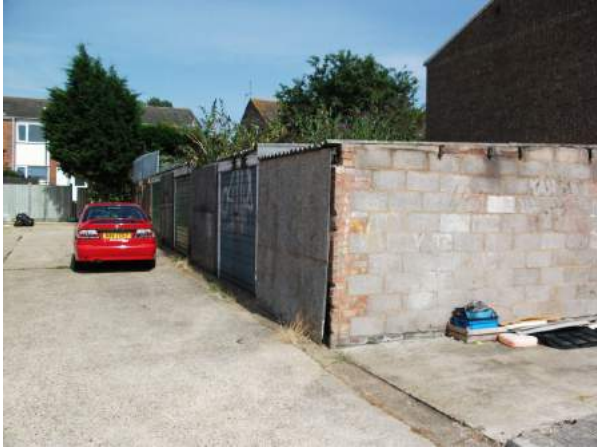
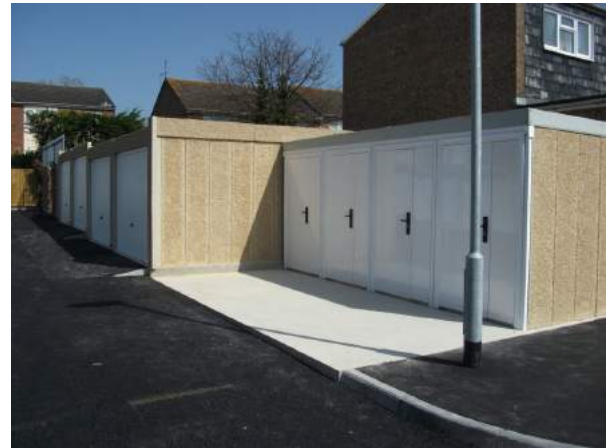
Maximising the use of land area is in the interests of everyone, and with many garages used as storage units the possibility arises to fill-in with our MiniStor's where space does not permit an extra garage. Note how Colchester Borough Homes used an area, not big enough for garages to erect our MiniStor's and gain extra revenue.

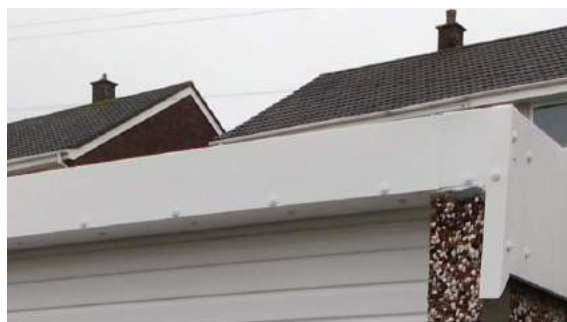
Yes, this is the front of the garage. In our System 8FX we use accessible square flow uPVC guttering that is easily cleaned by anyone with a short ladder and no tools.

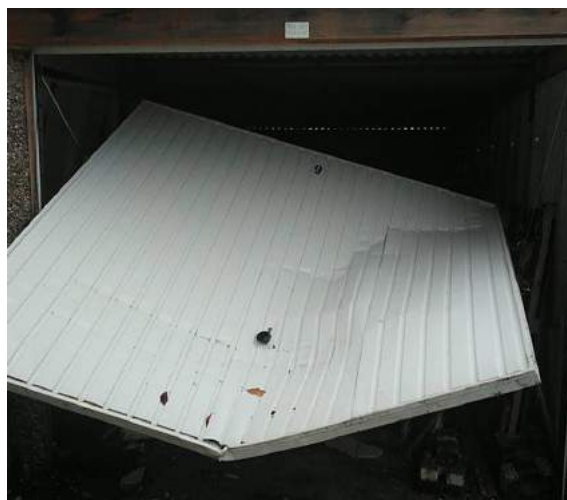
With a roller shutter door (RSD) only the damaged slats need changing and these cost about £12 each at current prices. With labour changing 3-4 slats should cost no more than £100-£130, and can be carried out by the owners/property managers maintenance staff where available.

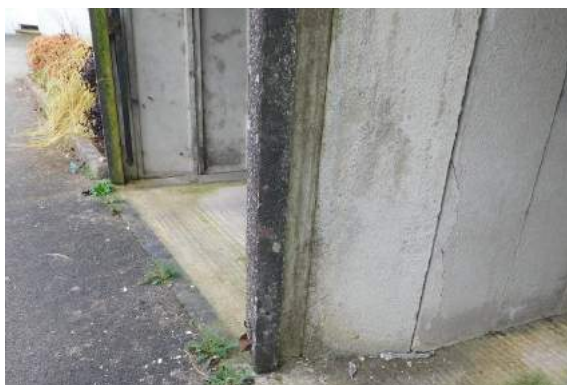
After dented doors concrete posts are the next casualty. Shown here is the effect of a sideways hit on an interpost. The interpost has moved to the left. The dividing wall has been buckled and the end wall and post also moved to the left. This is clear from the exposed break in the line of the floor fillet. If an end post is hit it normally cracks in one or more places.

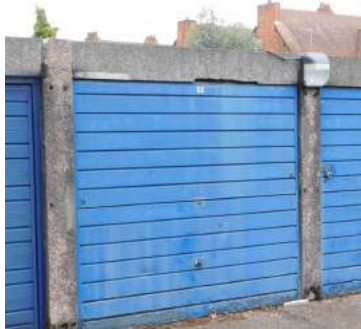
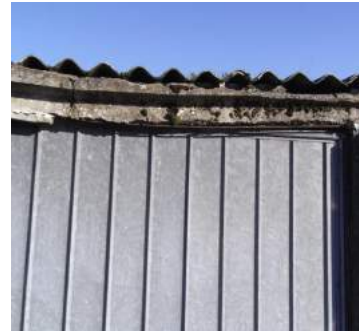
This is required where there has been some kind of impact. A vehicle hits the garage or a tree falls on the roof for instance. Occasionally a garage within a block may have deteriorated to the extent that chunks of concrete are falling from a lintel that is breaking up. In this case it is better to look at the block as a whole for there will be other garages in the block in a similar state and total refurbishment of the block will prove to be much more cost effective. Apart from the Marley and Leofric Ranges of garages we have moulds for other brands long since defunct and can usually provide a viable solution. However these replacement parts contain hand-made wire reinforcement elements and require careful handling to ensure no cracking in the hardening stage, and even with great care taken the yield is not high and the costs reflect that. Evidence of the difference in the reinforcement between Marley and other brands can be seen in how they disintegrate. Marley units spall (concrete comes away from the rebar) System B from a manufacturer long since gone, breaking up along the lintel. Note in the photograph how the concrete has collapsed onto the door which is now the only thing holding it up!

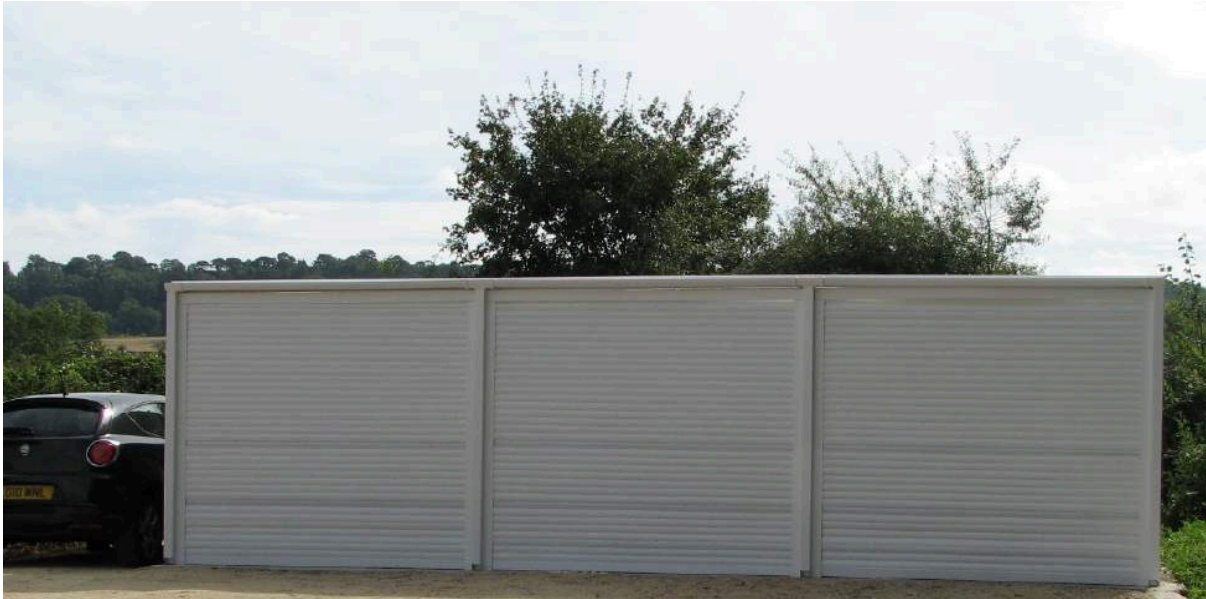
# System LX Battery Garage Detail

For over 60 years the construction of Battery Garages that feature built-in gutters and down pipes have continued to be constructed in the same pattern. Repair experience has shown us that a better arrangement was needed hence we have designed and released System LX.

System LX out features and will outlast any other battery garage system available today. Here you can read how and why:

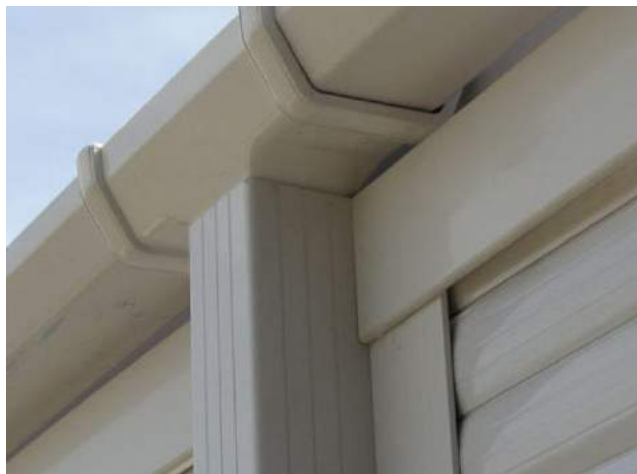
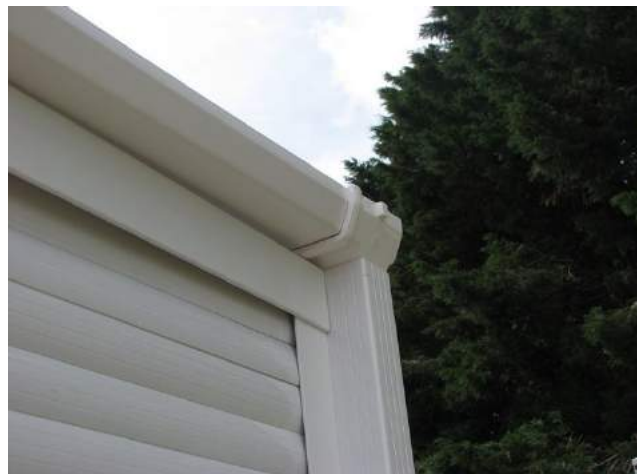
**Here are the images of what we have described**

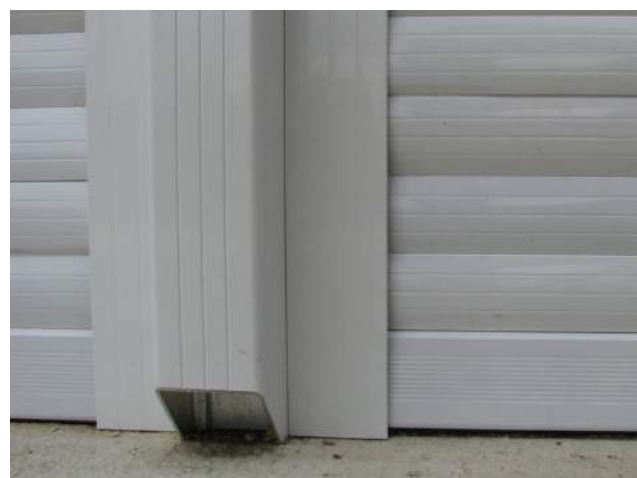
The aluminium downpipe/post will not block easily, unlike the interpost pipes of earlier models. In fact the new post/pipe has about three times the capacity of the original Marley design or the System "B" Type .Debris drops out of the pipe and is easily brushed away.

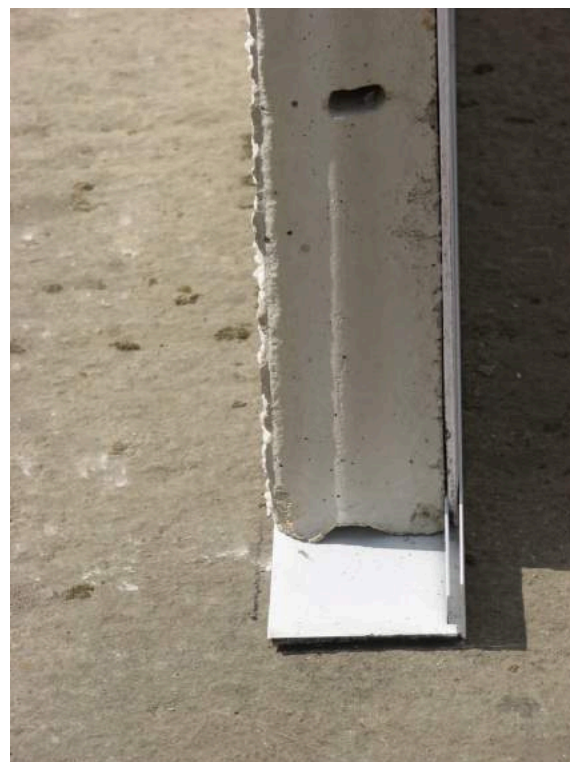
Cement filets crack-up. This is no laughing matter. Often in the past a cement filet was laid along the inside of the exterior walls. It only takes one severe frost to break the filet away from the panel base and the floor and in comes the water.

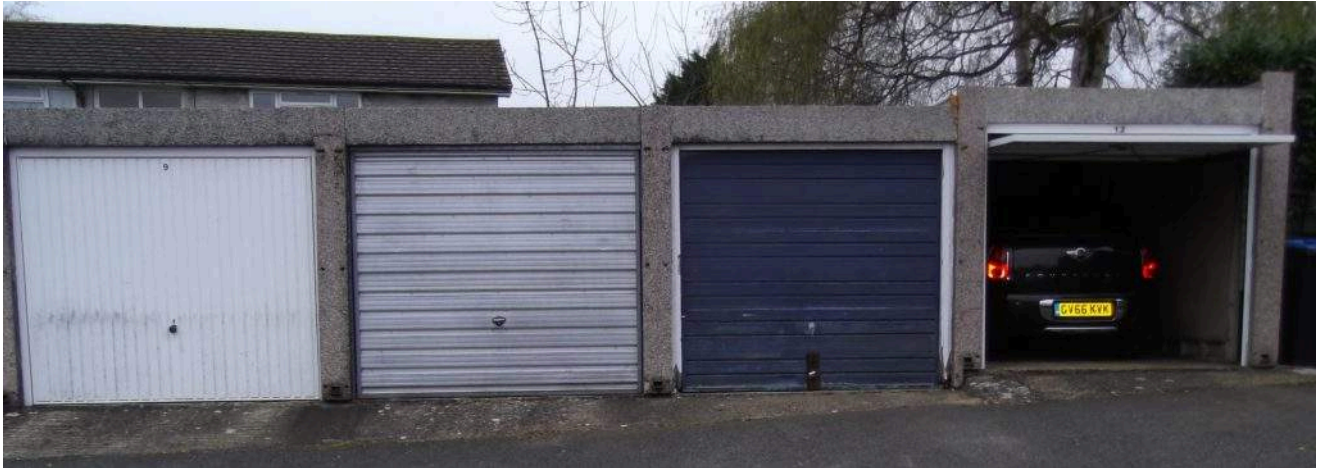
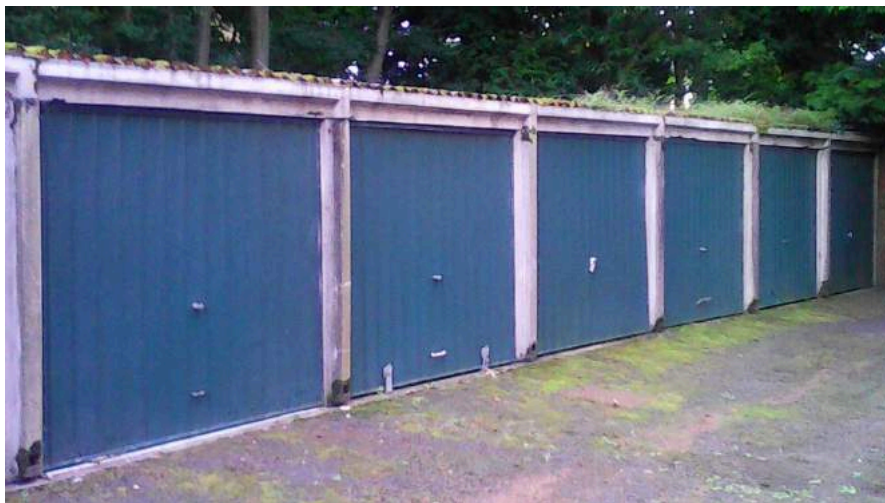
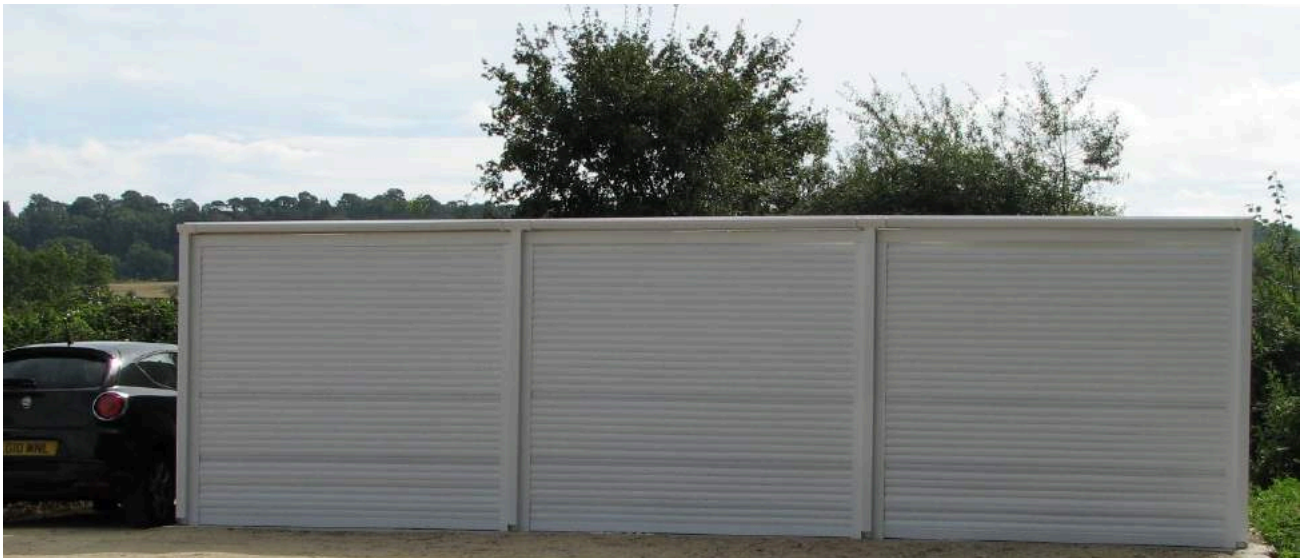
with new, maintenance-free fronts, and roller shutter doors, but retaining all the existing concrete shell structure thereby extending the life of your garage block for another 40-50 years.

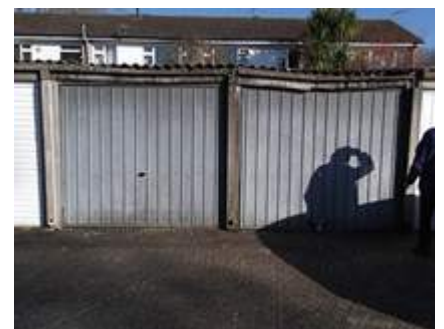
## **System B**

Very popular design. Often seen in the Midlands and the South. Manufacturer went out of business probably 50 years ago. All parts have been re-moulded by Leofric and are available. Can be converted to System X fronts and Roller Shutter Doors. For more information see Page 27.

System B battery garage form the garage stock of many local authorities and as the original manufacturer went out of business 30-40 years ago we have manufactured moulds for all 12 concrete components. Common problems are lintels failing, posts disintegrating, and door mechanism mounting panels cracking.

In the photo to the left the front of the post has fallen away exposing half of the downpipe and in the photo above the lintel has fractured. Probably still in place by collapsing onto the door and the door frame.

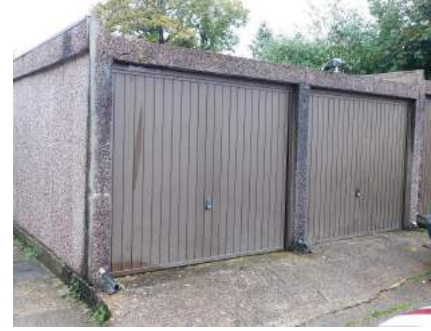
## System C

Similar to Marley and Leofric Models in that they feature 16" wide wall panels that are 7' high. Not tongued and grooved like Marley. Manufacturer went out of business about 10 years ago. Can be converted to System X fronts and Roller Shutter Doors. Few examples around.

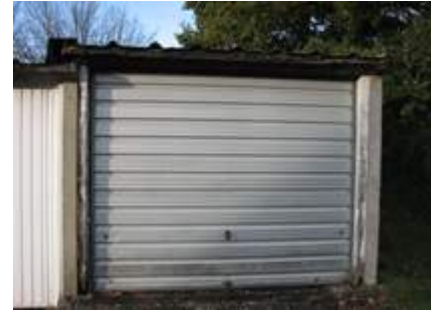
## System E

Unknown manufacturer. Posts are embedded in the base. Walls are Post and panel construction. No parts available. Best demolished. No Further information.

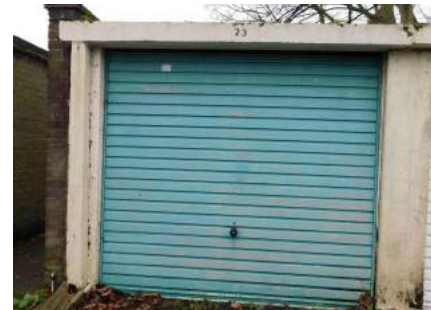
## System K-8F

This is a Post and Panel Garage with concrete fascia/gutter/lintels and downpipes. No parts available but easily converts to System X fronts

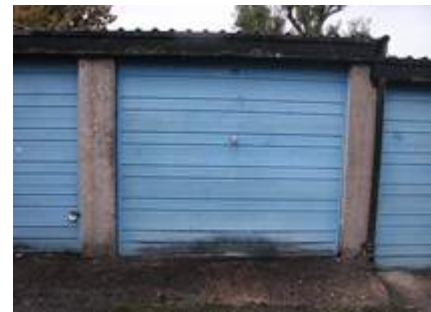
## System L

Early Leofric Model - all parts available. Can be converted to System X fronts and Roller Shutter Doors. For more information see Page 28.

System L battery garage (for [Leofric](#)) started life as a Banbury Garage. When Banbury split into Compton and Leofric, Compton dropped Battery Garages but Leofric continued with the product. That is why we can still supply parts, fifty or so years later. The main difference between System L and [System E](#) is that the System L is built from the rear corners forward whereas [System E](#) relies on posts sunk into the concrete base and then built backwards.

System L battery garage is simple. However the original lintel and front gutter design used a metal section, largely hand made. Today we would replace the fronts with System X components.

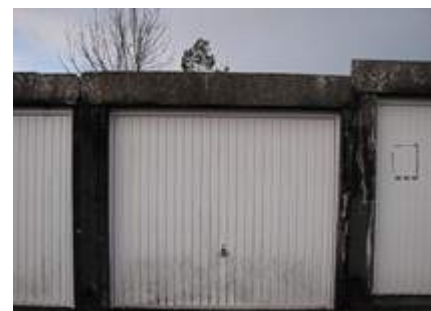
## System M-8G

Early Marley Model. All parts available. Can be converted to System X fronts and Roller Shutter Doors. For more information see Page 29.

The System M-8G battery garage was an early Marley product and can be identified by a number of characteristics but the two instantly recognisable ones are the construction using 16" panels combined with the unstoned, rounded-off edges of the panels.

These garages have lintel/fascias that in many cases have completely broken down (having been constructed over 50 years ago).

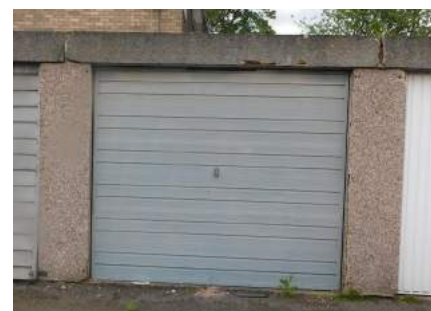
## System M8/9R

Very early Marley Garage - extra wide rear-sloping design using Marley A63 panels. Can be converted to System X fronts and Roller Shutter Doors.

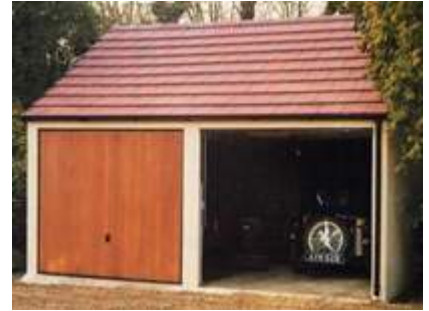
## System M-H

This garage style used Marley's Top-of-the-line Heritage Range in a Battery format. All parts are available. For more information see Page 30.

This System MH Battery Garage is based on the Marley (now Mayfair Garages) Heritage Model. It has an apex roof which sets it alone in the battery or system garage ranges. The model shown has a smooth panel finish whereas most have a dark, chipped stone surface as shown in the example needing repair! See page 8. All parts are available.

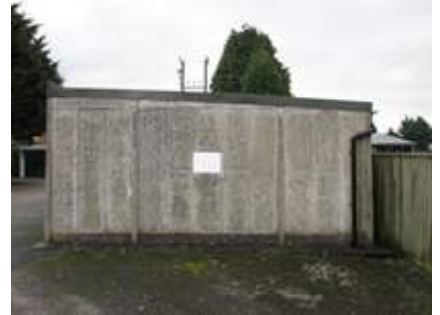
## System M-Q

Another early Marley design. Can be converted to System X fronts and Roller Shutter Doors. For more information see Page 31.

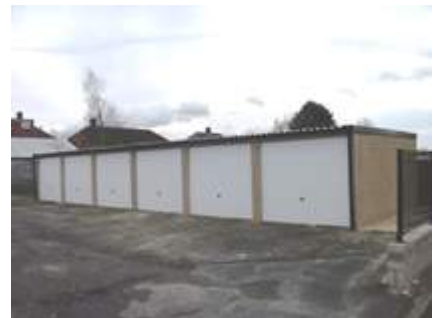
## System M-E8/9 F/R

Marley Economy Range. Available with 8' or 9' interior widths. All parts available. Can be converted to System X fronts and Roller Shutter Doors. For more information see Page 30.

These System ME8/9 battery garages are current Marley-designed Leofric built Models and seldom need refurbishment for deterioration but often require repair following vehicle collisions and falling trees or base disruption due to adjacent tree growth. All parts are available, however System LX components will fit to these units to extend building life and enhance appearance.

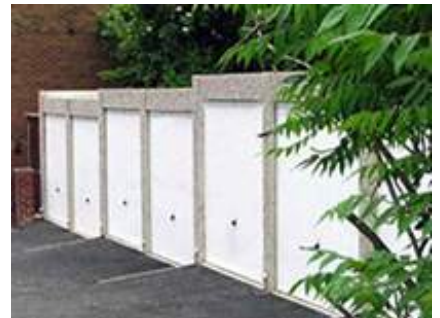
## System M8/9F

Current Marley design. All parts available and can be converted to System X fronts and Roller Shutter Doors. For more information see Page 32.

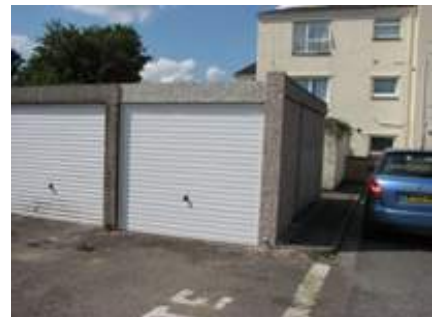
## System M8/9R

Current Marley design. All parts available and can be converted to System X fronts and Roller Shutter Doors.

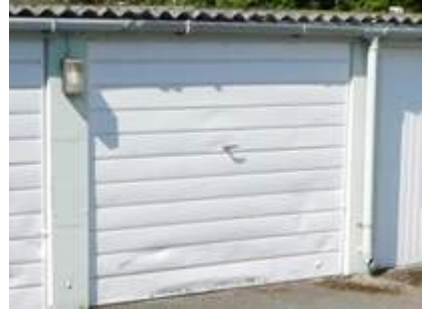
## System FMTF

Unknown manufacturer. Probably best demolished. For more information see Page 32.

This System MTF Battery Garage type is based on an early Marley Panel Garage and could be refurbished with System LX components on the fronts, aluminium posts and downpipes with uPVC gutters and fitted with Roller Shutter Doors. This concrete garage is similar to the MQ but has more exaggerated flared side/end posts.

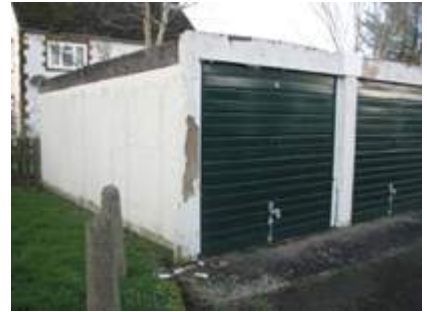
## System FMTR

For more information see Page 33.

This System FMTR Battery Garage type is based on an early Marley Panel Garage and could be refurbished with System X components on the fronts with aluminium posts and fitted with Roller Shutter Doors. To the rear we would fit uPVC gutters and downpipes. This concrete garage has the flared side posts but not the tapered wedges that create the roof slope of the MQ.

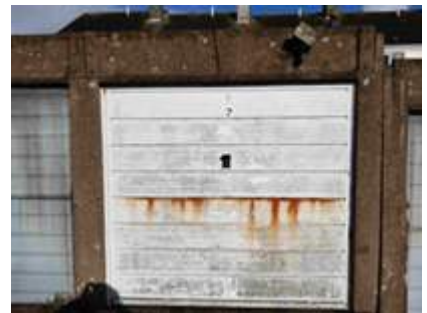
## System P

For more information see Page 34.

These garages can be identified by the “V” shaped moulding in the middle of the front fascia. Also this is one of the few Battery Garage Systems that is constructed with posts and panels similar to the System L. System L panels would probably fit although the appearance would differ slightly. No fascia moulds exist for this type. System X parts can be employed across the fronts. The brand is unknown at the present time but they have been observed from Dover to Plymouth.

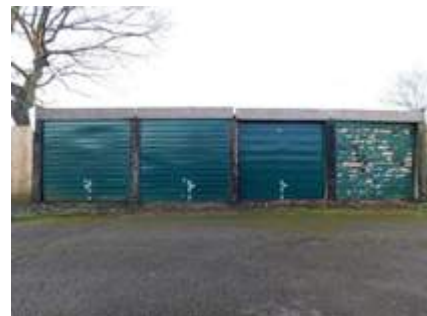
## System TAR

Manufacturer long gone. If significant quantities of parts are required then moulds can be made. For more information see Page 35.

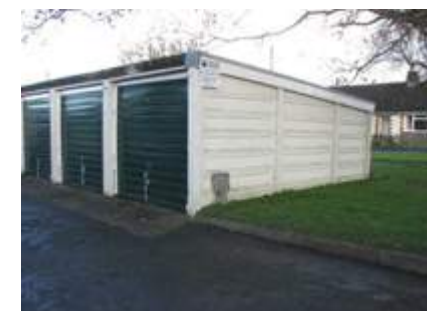
## System TPP

Manufacturer long gone. If significant quantities of parts are required then moulds can be made. For more information see Page 36.

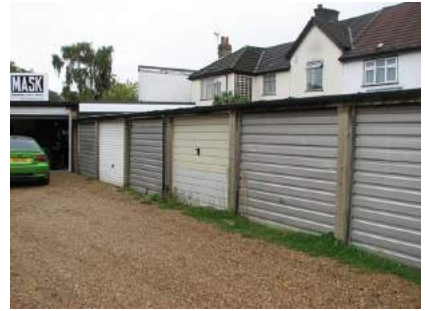
## System V

Probably Cotswold. Long gone, no parts available. Walls are large Four foot square panels. No parts available. For more information see Page 36.

This System V battery garage is a post and panel arrangement with large panels especially in the rear wall. Posts, lintels, inner and rear panels usually show evidence of cracking and when the lintels crack they fall down onto the door frames rendering the garage unusable.

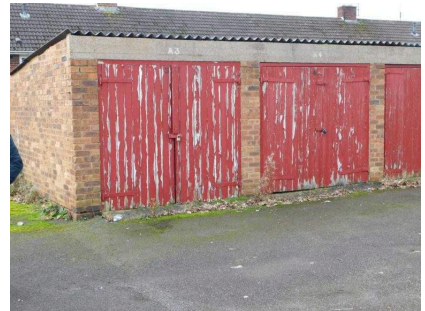
## System WMR

Obsolete design. No parts available. For more information see Page 37.

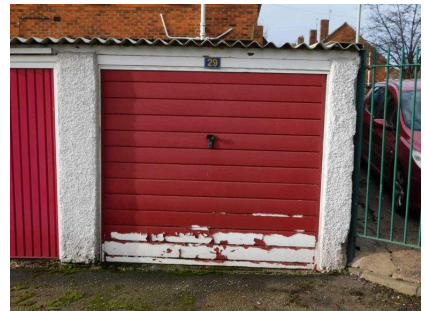
## System WPF

Obsolete design. No parts available. For more information see Page 37.

This system WPF Battery Garage is an unusual design incorporating a roughcast rendered “buttress” shape between garages. Roller shutter doors can be fitted to modernise the look and provided much cheaper repair costs in the event that doors are damaged by collision.

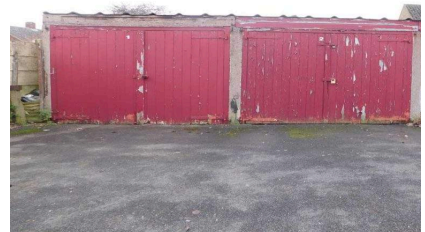
## System WNR

Obsolete design. No parts available. For more information see Page 38.

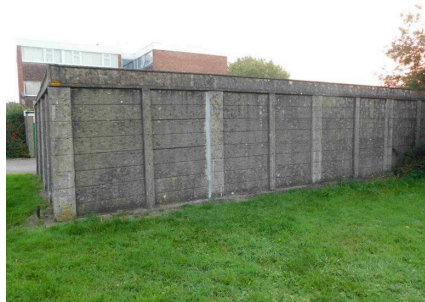
## System YPP

Obsolete design. No parts available. For more information see Page 38.

This is a Post and Panel System YPP battery garage that is not common and we have only seen it in one location. Although similar to System L the joints of the two systems are not compatible, neither can the new aluminium posts that can replace System L corner and interposts be used with this System. These garages have had their life and need to be replaced.

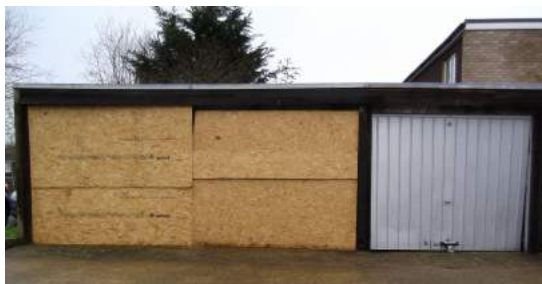
**Doors Before**

These designs can be refurbished with [System LX](#) components, usually for considerably less than replacing the concrete parts and our new powder-coated aluminium extrusions will last indefinitely. Even without the change to [System LX](#) the up and over doors on System B battery garage units can be fitted with our roller shutter doors, as in the photo below.

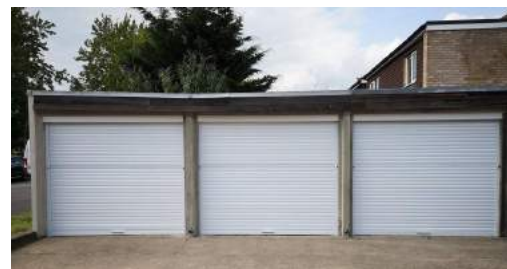
**Doors replaced with Roller Shutter Doors**

In the event of a door collision our roller shutter doors are far easier and cheaper to repair with damaged slats costing only a few pounds each in replacement costs, versus about £900.- or more for a new up and over door with fitting.

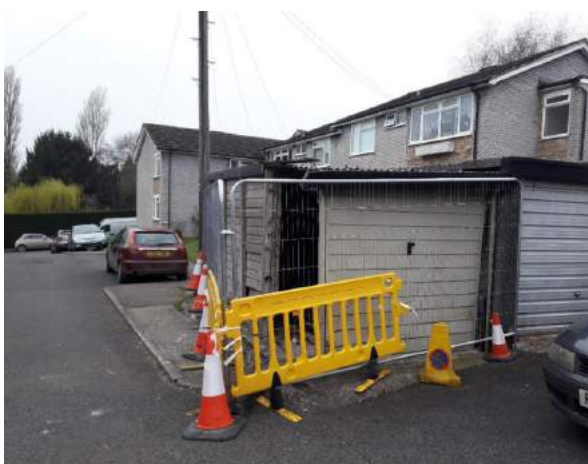
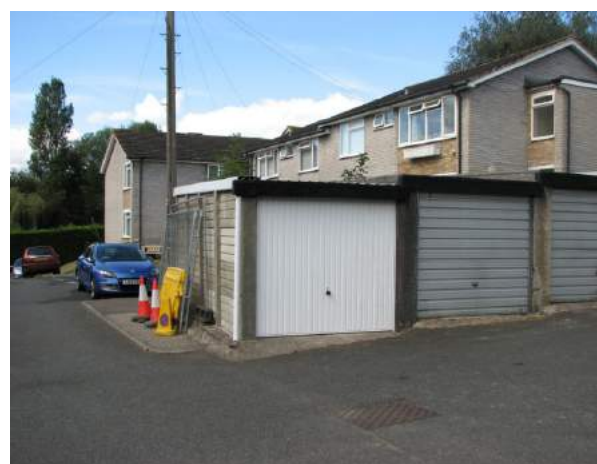
However in some cases re-manufacturing the metal box is more desirable as it matches adjoining garages as shown below.

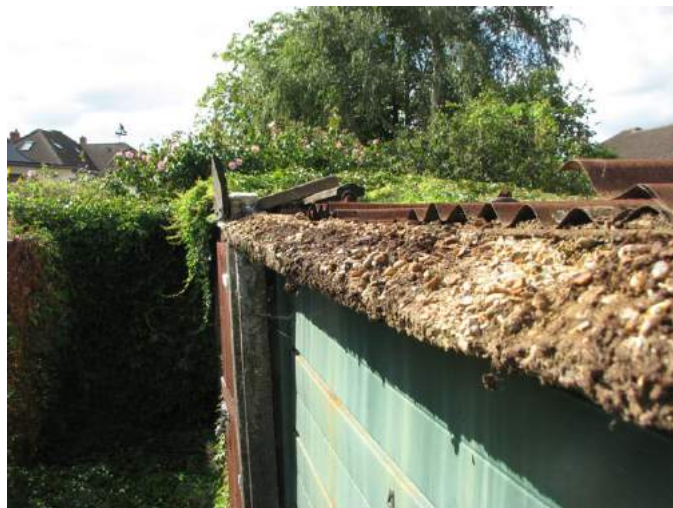
In the photo below we can see that the entire fascia has become crumbled aggregate.

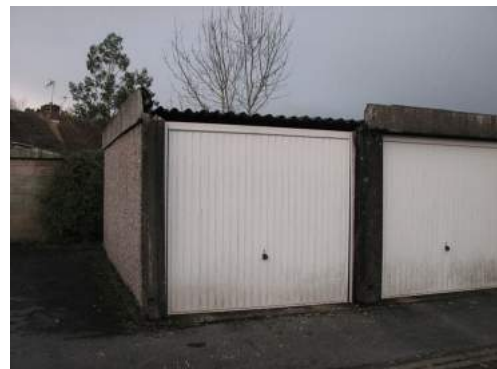
Recently the lady using this System M-8G garage shut the door (perhaps too vigorously) whereupon the lintel on her garage, similar to the one on the right, crashed to the ground just missing her. Obviously this is dangerous to the person shutting the door or to children using the garage front for soccer practice or similar activity.
