## **The Definitive Guide to Battery/System Garage Refurbishment**

***The first section of this website / booklet shows examples of over 20 Battery or System Garage types and their before and after states.***

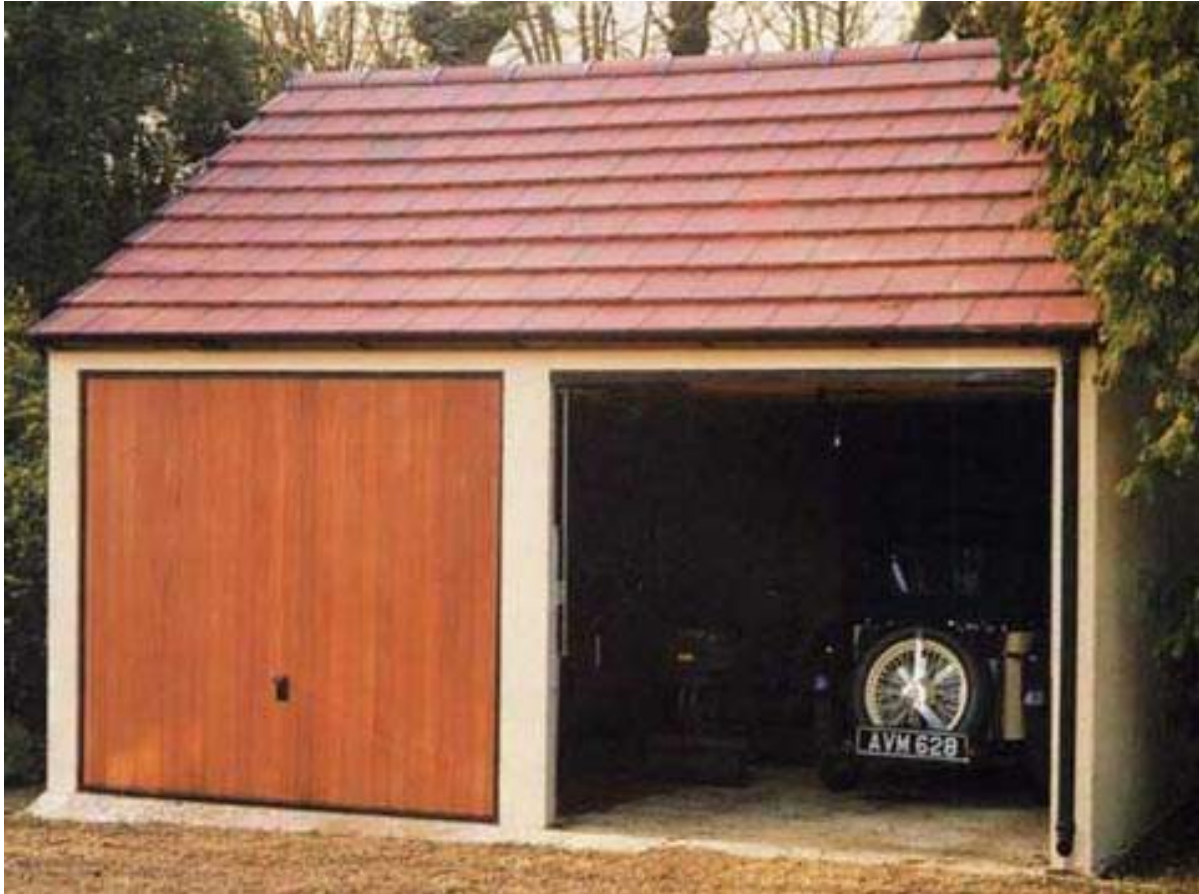
### **System M-H Battery Garage Detail**

This System MH Battery Garage is based on the Marley (now Mayfair Garages) Heritage Model. It has an apex roof which sets it alone in the battery or system garage ranges. The model shown has a smooth panel finish whereas most have a dark, chipped stone surface as shown in the example needing repair! See page 8. All parts are available.

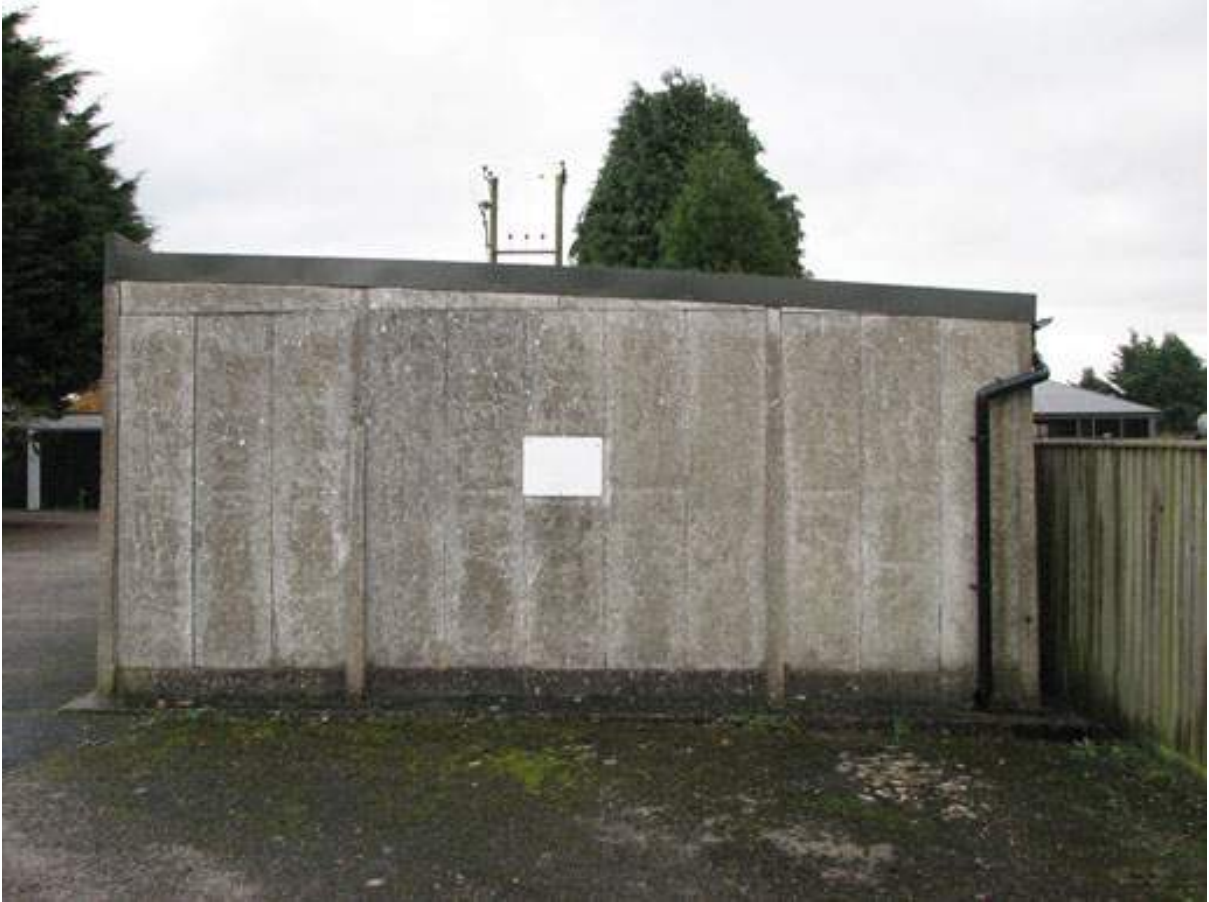
This System MQ battery garage is a very early Marley design known as The Marley Master. The System MQ battery garage panels are 16" wide and 6' high, they are tongued and grooved and sit on a 6" plinth. This particular example has been completely re-faced so only the end and rear walls give any indication of the type.

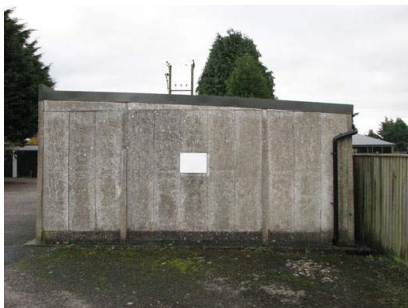
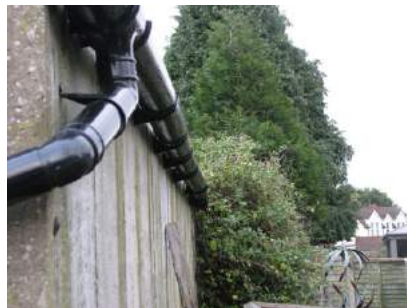
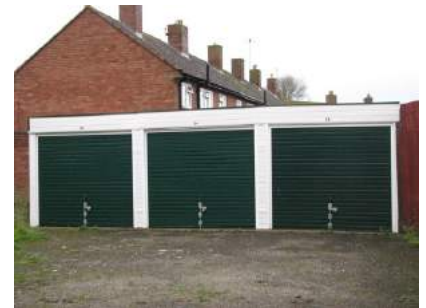
Note the posts located between the first and last three panels which are themselves slightly flared out towards the base. This type of construction is unique. Also note the wedge shaped concrete mounted on the side panels to give the roof drainage pitch.

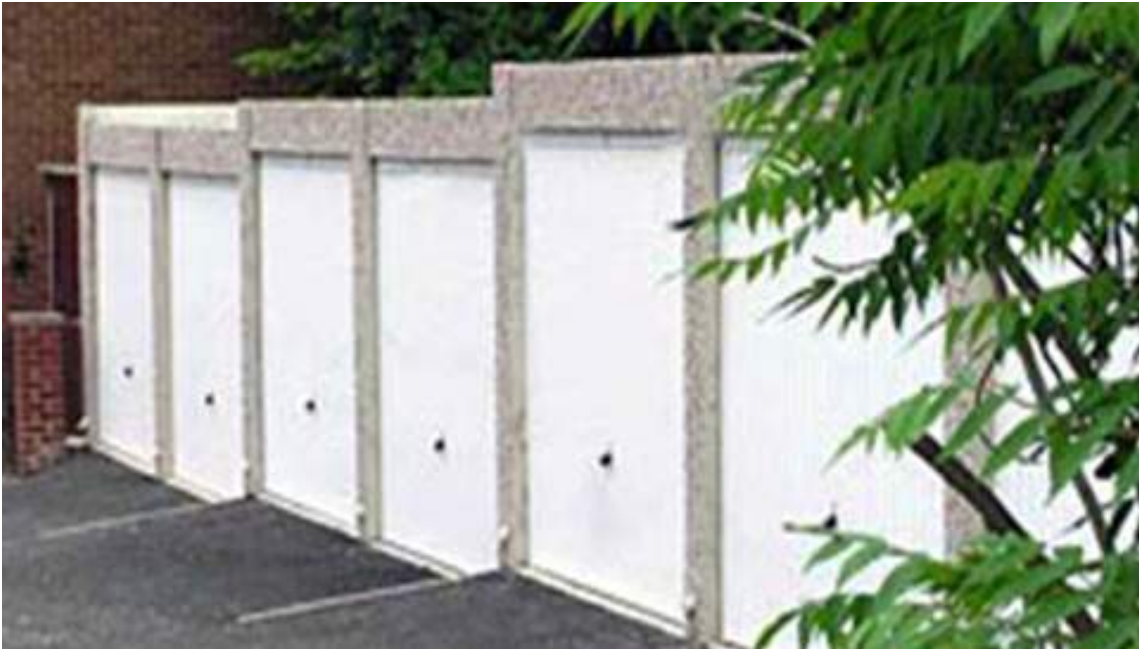
This is how the M-8F looked after a repair. The Type indicates the slope of the roof, F slopes and drains to the front. The R slopes backwards and drains to the rear. The 8 or 9 indicates the internal width of the garage. All System M8F/R Garages can be converted into System X format.

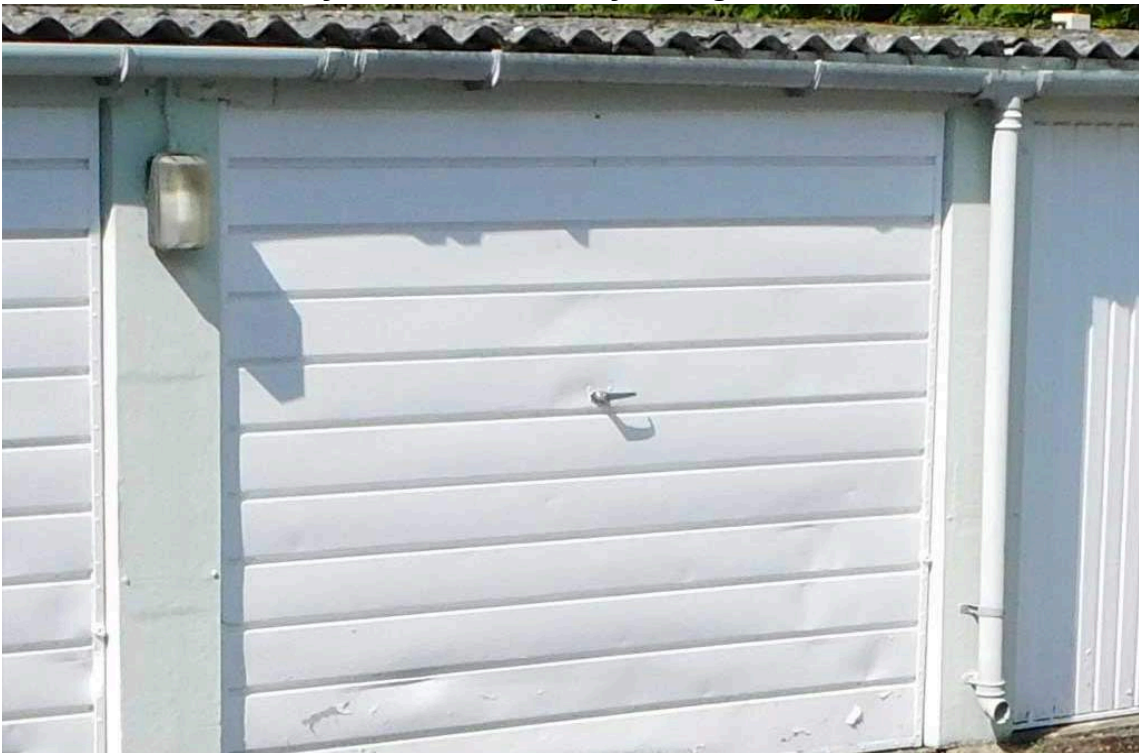
### **System FMTF Battery Garage Detail**

This System MTF Battery Garage type is based on an early Marley Panel Garage and could be refurbished with System LX components on the fronts, aluminium posts and downpipes with uPVC gutters and fitted with Roller Shutter Doors. This concrete garage is similar to the MQ but has more exaggerated flared side/end posts.

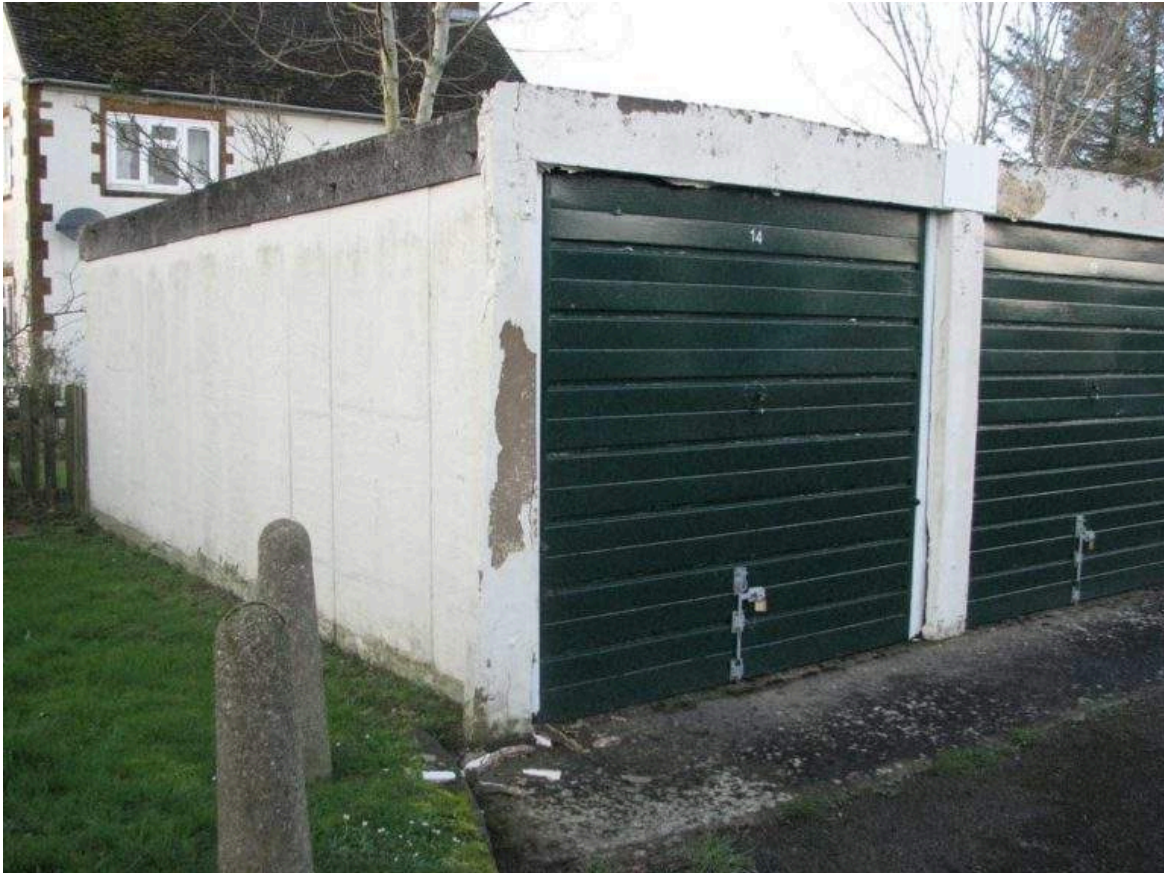
## System FMTR Battery Garage Detail

This System FMTR Battery Garage type is based on an early Marley Panel Garage and could be refurbished with System X components on the fronts with aluminium posts and fitted with Roller Shutter Doors. To the rear we would fit uPVC gutters and downpipes. This concrete garage has the flared side posts but not the tapered wedges that create the roof slope of the MQ.

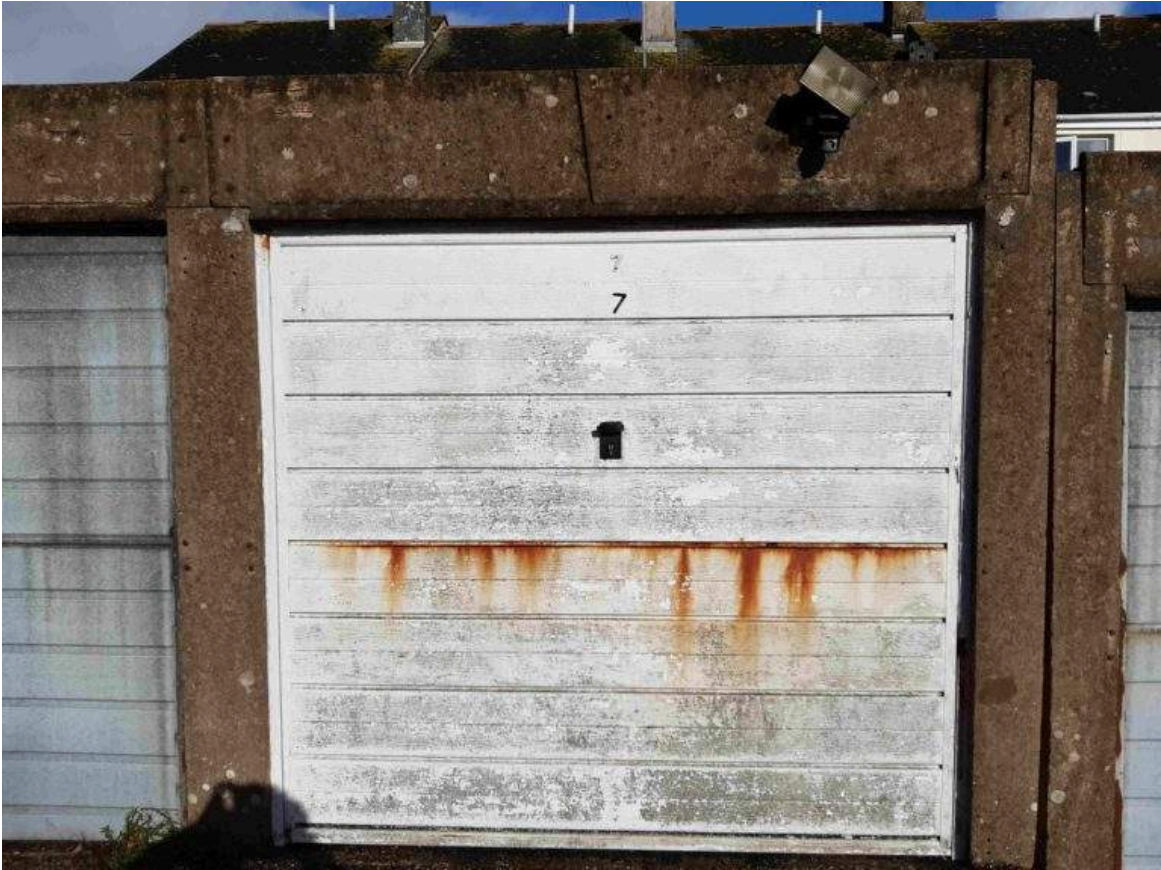
These garages can be identified by the “V” shaped moulding in the middle of the front fascia. Also this is one of the few Battery Garage Systems that is constructed with posts and panels similar to the System L. System L panels would probably fit although the appearance would differ slightly. No fascia moulds exist for this type. System X parts can be employed across the fronts. The brand is unknown at the present time but they have been observed from Dover to Plymouth.

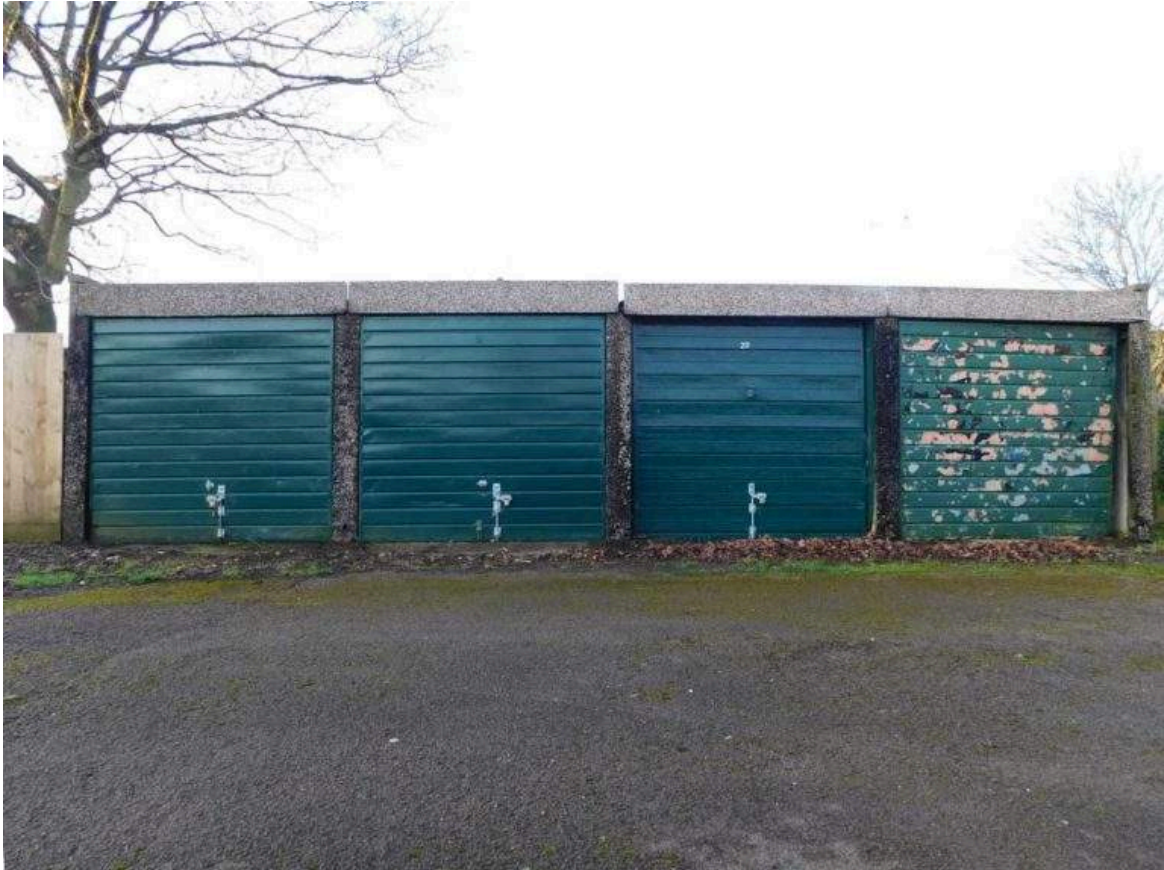
## System TAR Battery Garage Detail

This System TAR Battery Garage panel garage has a few identifying features. Note the square insert of the fascia notched into the post/downpipe.

Also the height of the side panels at 94", higher than Marley although still a 16" panel against the 24" panel of System "B".

Note also the gap between panels which shows evidence of a tongue and grooved joint although not as pronounced as a Marley joint. Can be upgraded to System X.

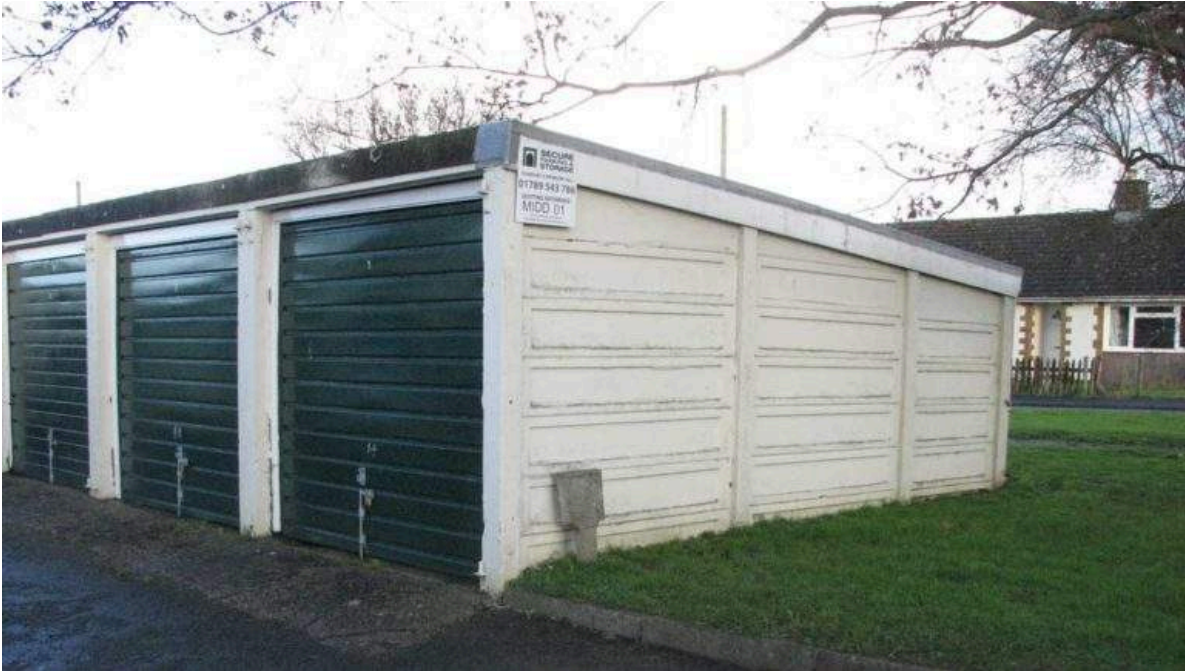
## System TPP Battery Garage Detail

This is a rare post and panel type that would be hard to convert to a System X frontal format.

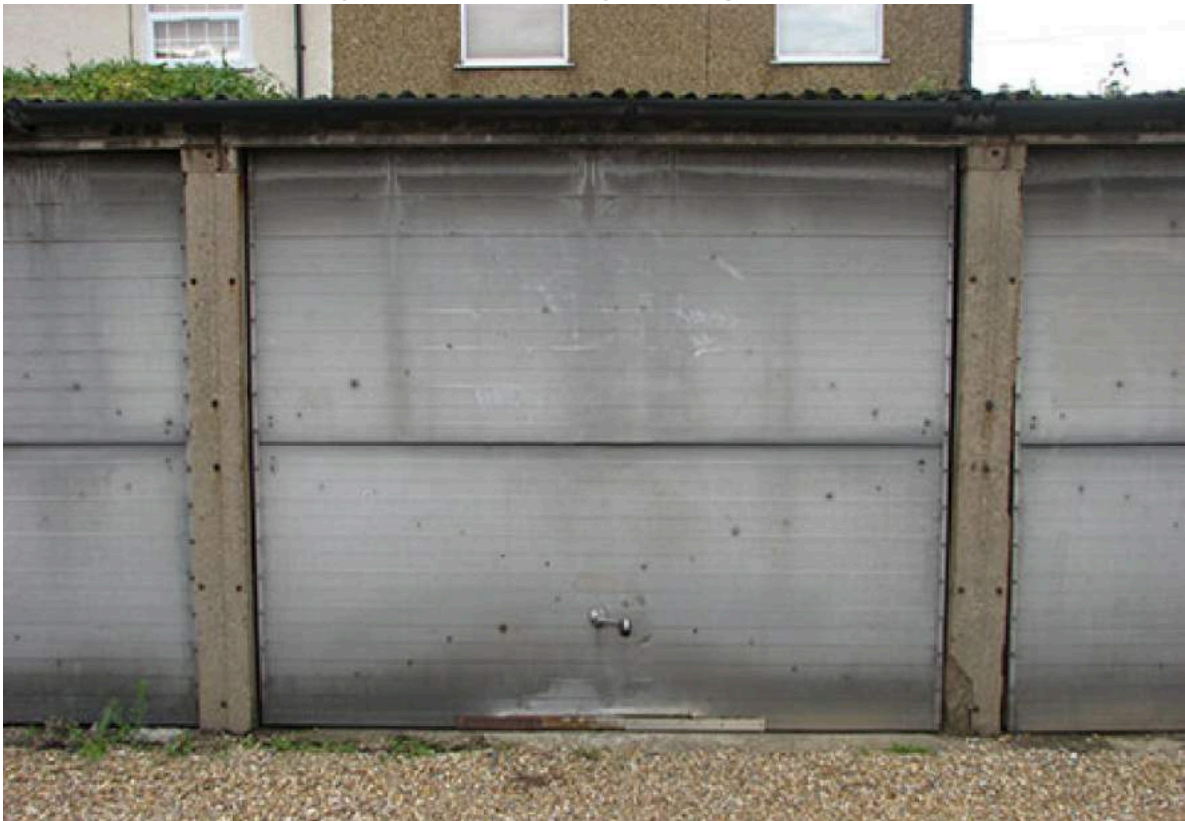
This System V battery garage is a post and panel arrangement with large panels especially in the rear wall. Posts, lintels, inner and rear panels usually show evidence of cracking and when the lintels crack they fall down onto the door frames rendering the garage unusable.

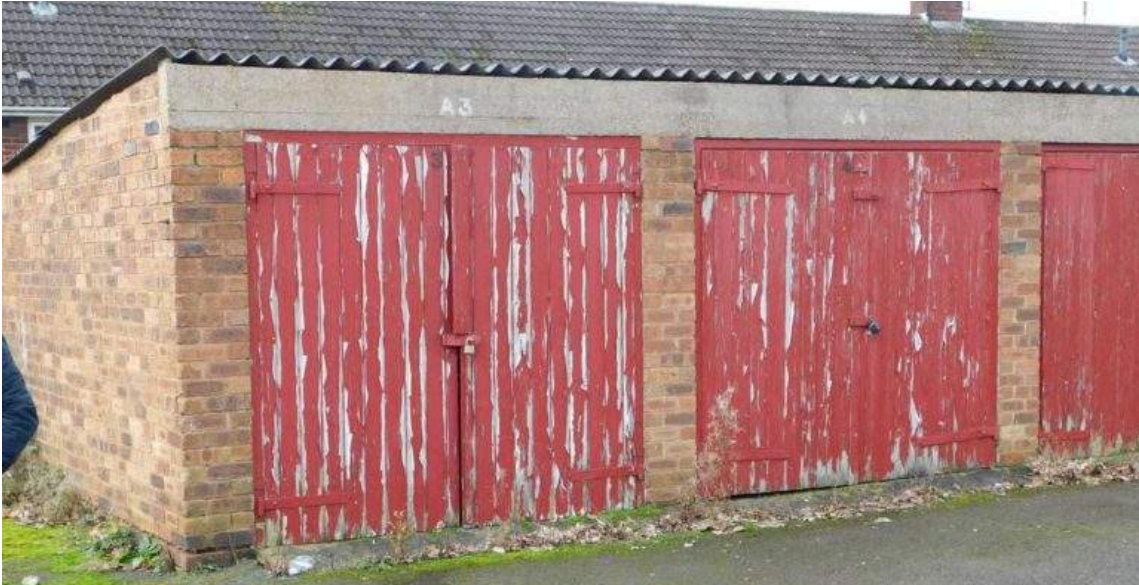
## System WMR Battery Garage Detail

This brick-built system WMR battery garage shell and solid concrete garage lintel design can be fitted with our new roller shutter doors and the concrete fascia cladded with soffit uPVC to give the garages a modern look extending their life for another 30-40 years.

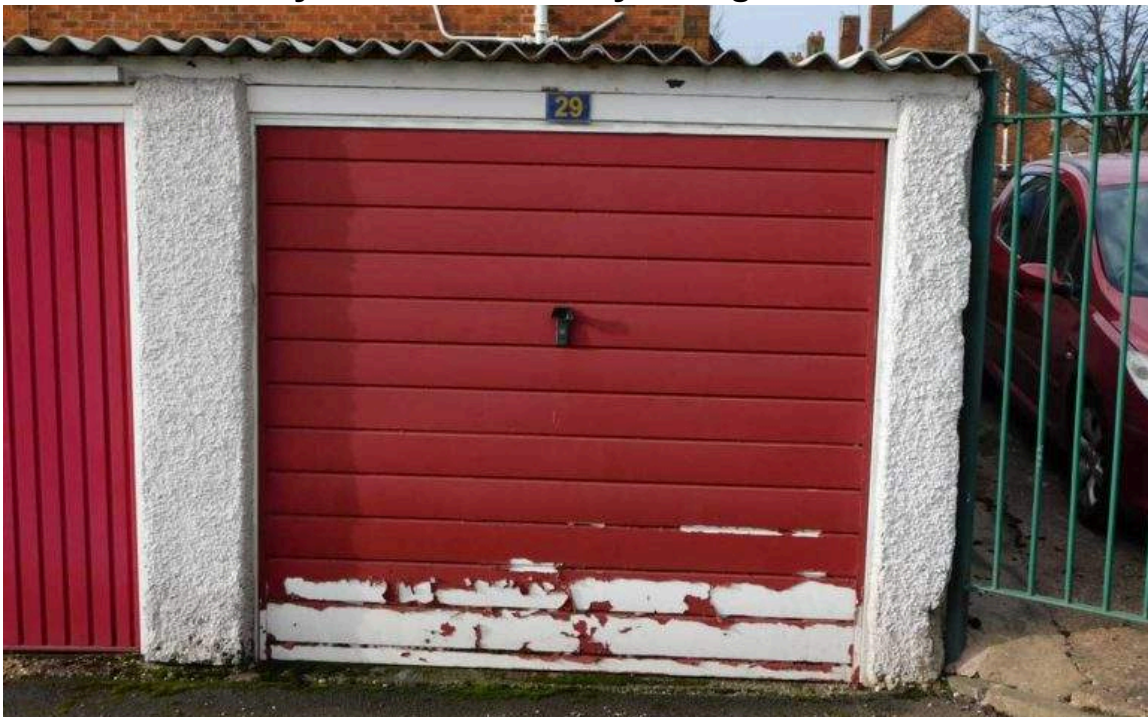
## System WPF Battery Garage Detail

This system WPF Battery Garage is an unusual design incorporating a roughcast rendered “buttress” shape between garages. Roller shutter doors can be fitted to modernise the look and provided much cheaper repair costs in the event that doors are damaged by collision.

Here the “shell” is constructed with post and panel concrete sections which can often be retained for an extended useful life.

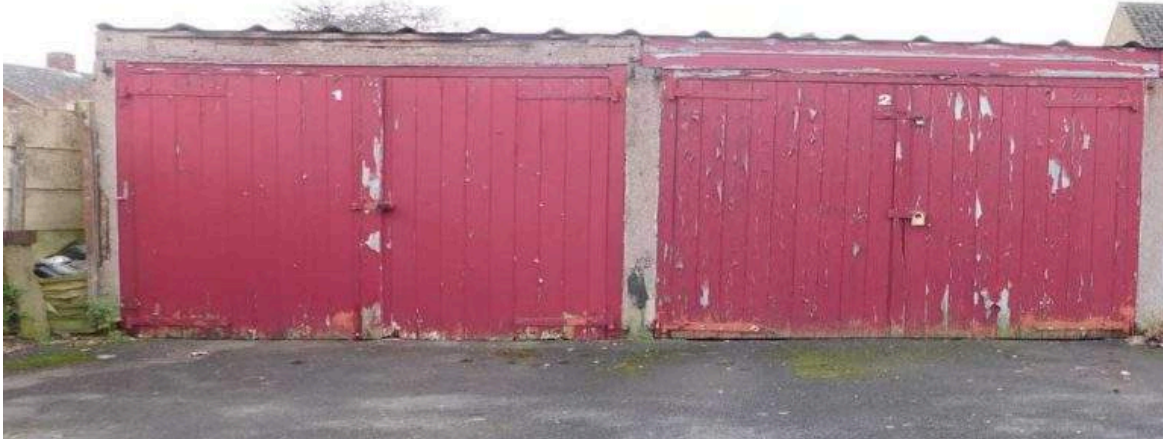
These rear-sloping roof garages are of post and panel construction with end and interposts sunk into the base. As the concrete lintels are often cracked we recommend replacing the lintels with powder-coated aluminium sections covered with uPVC soffit material and fitting the units with roller shutter doors.

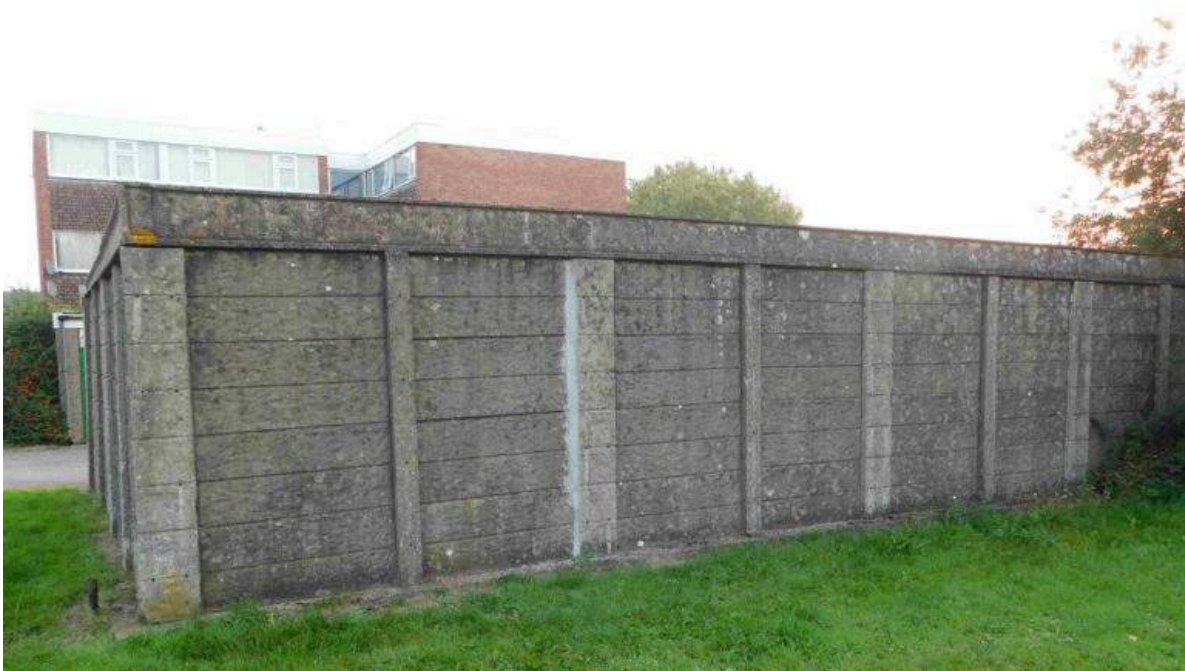
## System YPP Battery Garage Detail

This is a Post and Panel System YPP battery garage that is not common and we have only seen it in one location. Although similar to System L the joints of the two systems are not compatible, neither can the new aluminium posts that can replace System L corner and interposts be used with this System. These garages have had their life and need to be replaced.
